INFRARED DETECTION OF CONCRETE DETERIORATION

TECHNICAL REPORT RSC-02

July 1969

TEXAS A&M UNIVERSITY
REMOTE SENSING CENTER
COLLEGE STATION, TEXAS

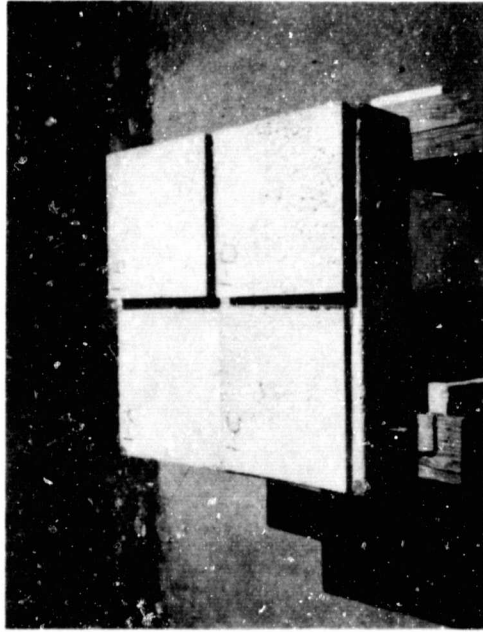
SPECIMEN I - 1a

Specimen I, (Fig. 1a), is a 7 inch thick structural lightweight concrete slab approximately 3 feet square and is elevated 2 feet 9 inches above the ground. The slab is in sound condition and has a smooth surface texture. The top surface is divided into 4 square areas approximately 18 inches on a side, three areas having concrete overlays and the fourth area, area A, in the original condition. Area B has a 1 5/8 inch thick, rough surface, bonded overlay. Area C has a 1 5/8 inch thick, rough surface, unbonded overlay, and Area D has a 3/4 inch thick, rough surface, unbonded overlay. A layer of

polyethylene plastic separates the C and D overlays from the slab. The overlays are separated by one inch spacings, are subject to ambient air temperature at all edges, and are of normal weight concrete.

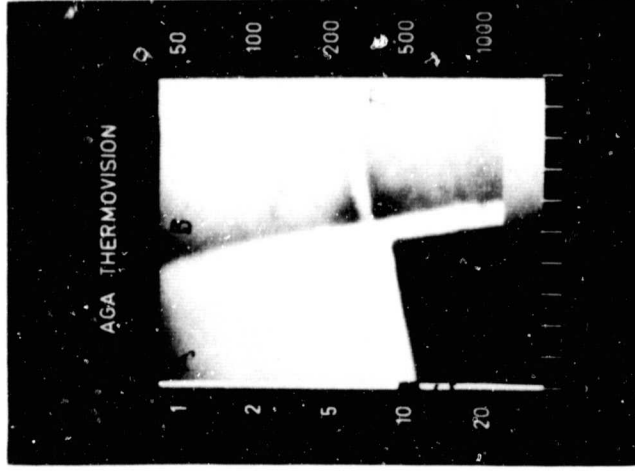
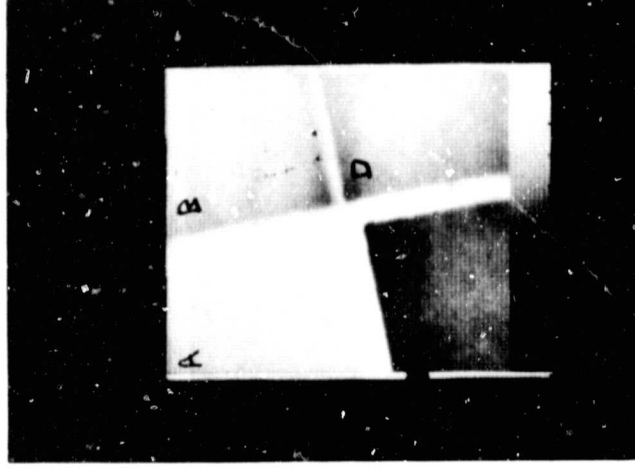
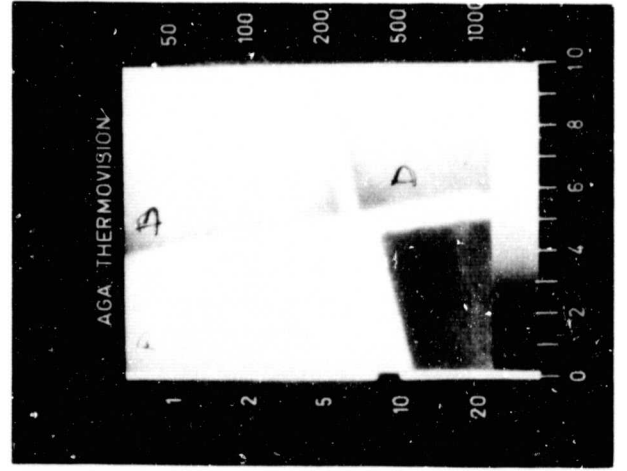
Plate I - Plates 1a and 1b contain tests results of specimen I. Photos 1b, 1c, and 1d are morning shots depicting area C as the coolest and A as the warmest, with B and D equivalent in 1b and slightly different at 1d. Relative temperature levels (RTL) are equal to ten degrees while the darkness levels (DL) vary. Photo 1e is the same thermogram (TG) as 1f except for an isotherm (IT) superimposed upon it. The concrete temperature is 80°F with the air temperature 75°F. Area B is about four degrees (4°F) warmer than area D. This difference began to appear 1 1/2 hours after sunset. The unbonded area (D) had cooled throughout. The bonded area (B) had cooled only on the edges. Photos 1g, 1h, and 1i show temperature differences between B and D at various periods. Figure 1g and 1h are an evening photograph of equal RTL and DL showing that area D became cool faster than B. Photo 1i, taken prior to sunrise, still shows area B warmer than D. Photo 1j, (areas A and C)

1b 6-5-69 8:00 P.M.
ABCD

1c 6-5-69 8:20 P.M.
ABCD

1d 6-5-69 8:40 P.M.
ABCD

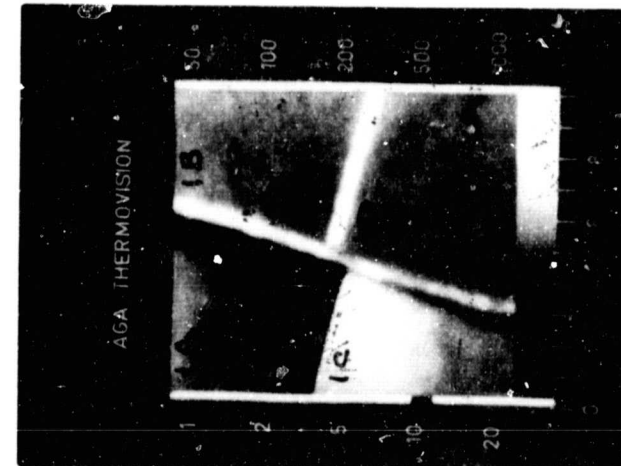
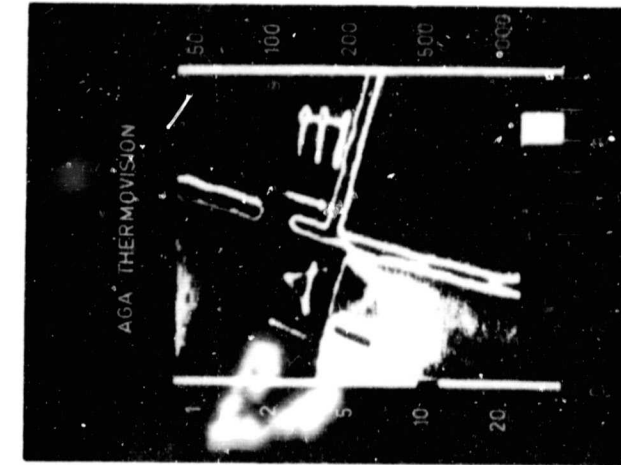
shows area A (white) as being warmer two hours after sun-down. Photos 1k and 1l show the TG and IT of the specimen. Taken on a cloudy afternoon, both 1k and 1l show area C as the warmest. The warm, light portion between the areas is wood at a higher temperature than most of the concrete.

1k
ABCD
6-4-69 Mid-Afternoon
Cloudy

1l
ABCD
6-4-69 Mid-Afternoon
Cloudy

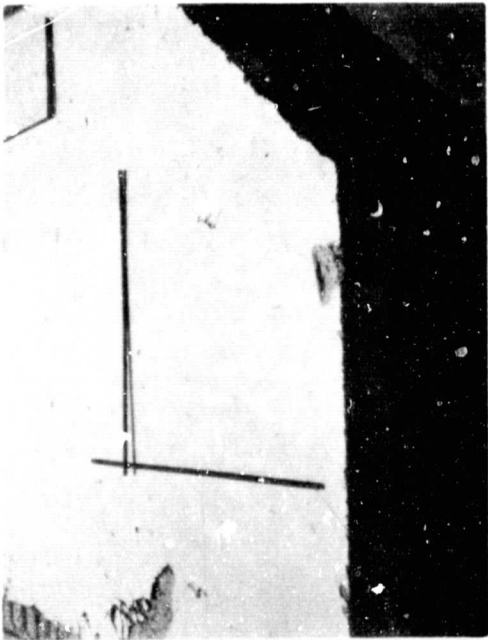
SPECIMEN II - 2a

Specimen II, (Fig. 2a), is a three foot square area of a 10 foot wide octagonal slab, 7 inches thick. It is lightweight concrete, 4 years old, and was tested to failure in another program. This octagonal slab has cracks, almost parallel to the plane of the slab, at varying depths at the center and extending to about two feet from the center. The slab was elevated above the ground approximately 28 inches and contains 5/8 inch diameter steel reinforcing bars, approximately 6 inches apart and 3/4 inch below the surface. Specimen II is an outer portion of the slab, consisting of both sound and fractured portions. The surface was the bottom of the slab when cast and has a smooth texture over the sound portion.

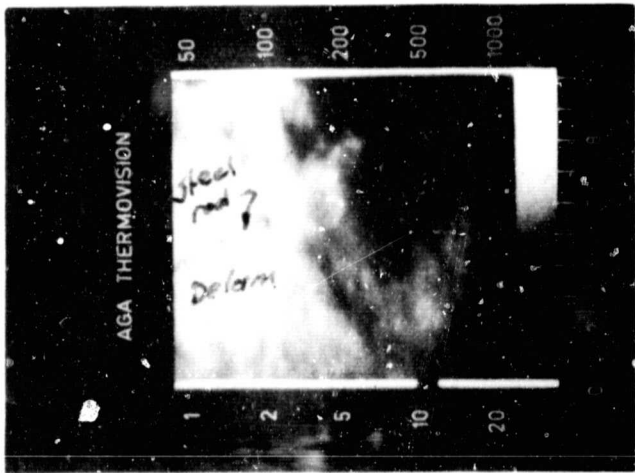
Plate II - Plate II has test results of specimen II. Several metal rods were used to outline sections, as seen in the photos. Photos 2b and 2c, taken on a cloudy afternoon, show a rod lying on unsound areas having cracked underportions. The solid areas are very dark, while the delaminated areas are very white. In photo 2b deep cracks appear as light gray. Both photos have equivalent DL's and RTL's.

2b 6-4-69 Mid-Afternoon
solid (dark) vs. delaminated area

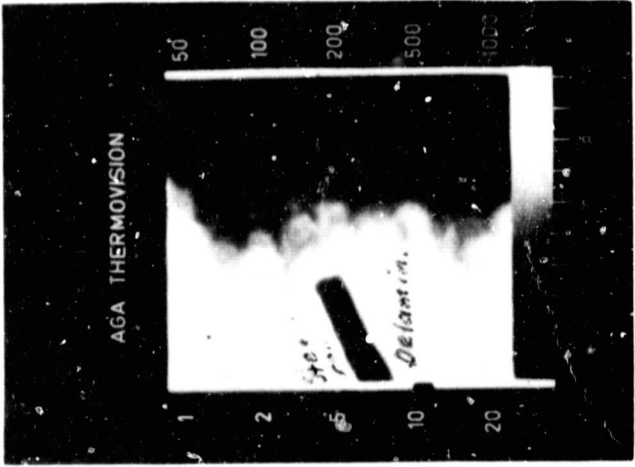
2c 6-4-69 mid-afternoon
rod in delaminated area cloudy

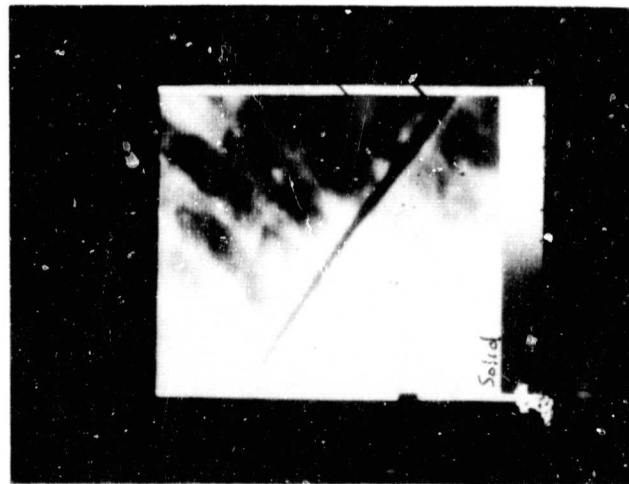
Photo 2d, taken in the evening, depicts a revision of shades. The rod was used to separate sound and unsound portions of concrete. At this time, the concrete was giving off heat, leaving the delaminated areas up to seven degrees cooler than the solid (RTL=10, DL's of 2 and 9 respectively). The solid areas are white and the delaminated areas gray to dark. Straight white lines running diagonally across the photos 2d, 2e, and 2f are the steel support bars under the surface.

2d 6-5-69 8:08 p.m.
reinforcing rods showing through
solid & cracked area

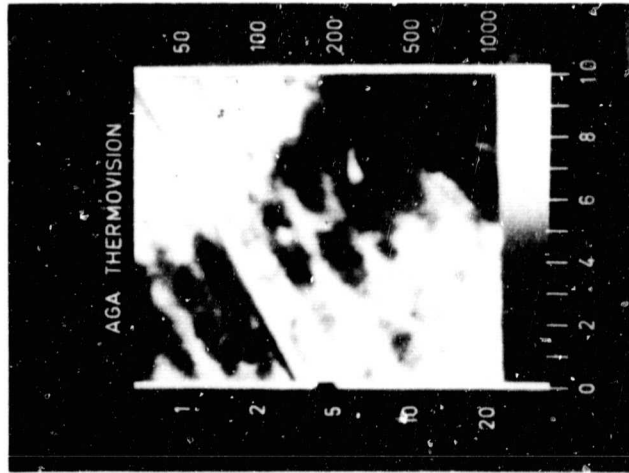
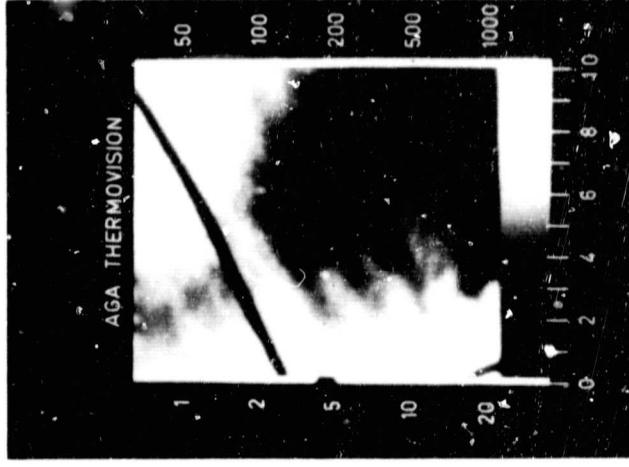
Photos 2e, and 2f, evening shots, show delaminated areas as dark. The area shown in 2e was doused with 77°F water and allowed to dry for two minutes, after which photo 2f was

taken. The focus is different for these two shots causing a darker appearance of the delaminated areas for 2f. Again the reinforcing bars can be seen.

2e 6-6-69 8:05 p.m.
just shaded

2f 6-6-69 8:08 p.m.
2min. after wetting with 77°F water

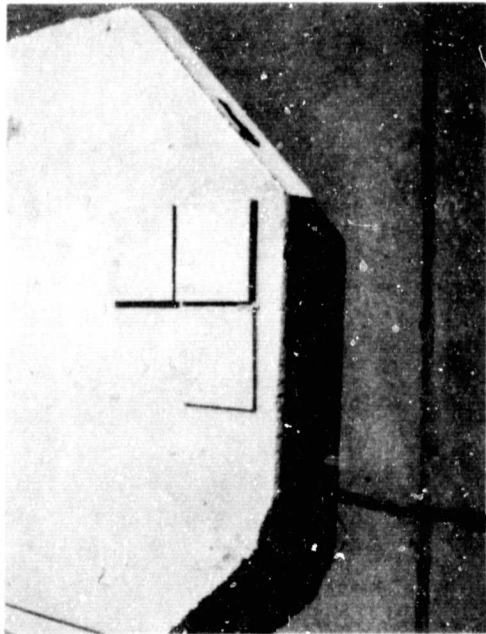
SPECIMEN III - 3a

Specimen II, (Fig. 3a), is another section of the lightweight slab containing Specimen II. This specimen is a three foot square area with overlays designed and arranged as Specimen I. The overlays are of the same type of concrete as the slab. This section was chosen such that areas A, B, C, and D have equal parts of sound and delaminated under-structure. The slab surface has a smooth texture with only slight occasional cracks. The overlays, as in Specimen I, have a rough

surface texture and are separated by one inch spacings.

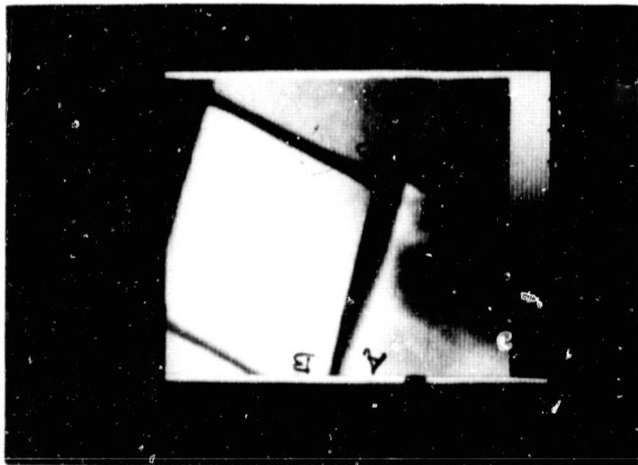
3b
ABCD
6-5-69 8:25 p.m.

Plate III- Plate III has test results of specimen III. Photo 3b, taken in the evening, shows area A as delaminated. Area C is the coolest area, and area B the warmest. Photo 3c, taken later in the evening, shows area D as having cooled faster than area B; D being relatively darker. The DL and RTL, changed between photos, affected the relative darkness of areas. Pictures 3d, 3e, and 3f area time sequence of morning shots. Photo 3d taken before sunrise shows the areas from warmest to coolest as A, B, D, C. As the sun was rising in 3e, the areas became indistinguishable. In 3f, the sun's reflection hampered differentiation of the small temperature differences of the concrete areas. The latter three photos have equal RTL's and similar DL's.

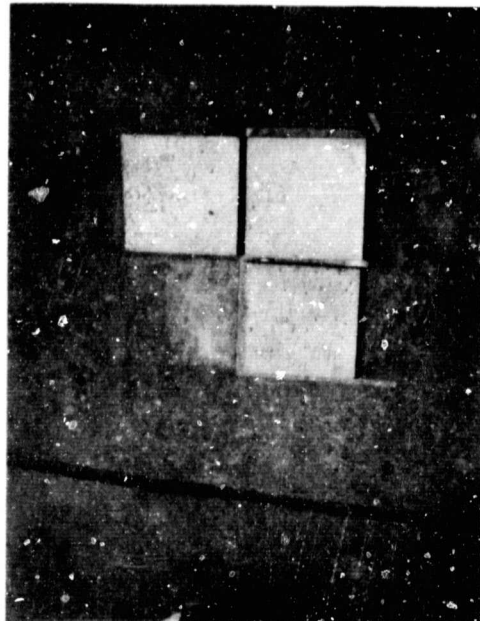
SPECIMEN IV - 4a

Specimen IV, (Fig. 4a), is a three foot square area of a concrete pavement. This 25 year old pavement of normal weight concrete has a rough surface texture. The entire pavement surface is sound. The specimen has four areas with the three types of overlays of the same design and type as Specimen I.

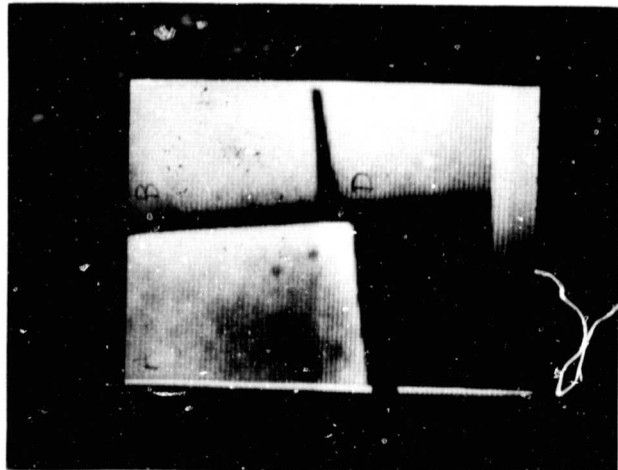
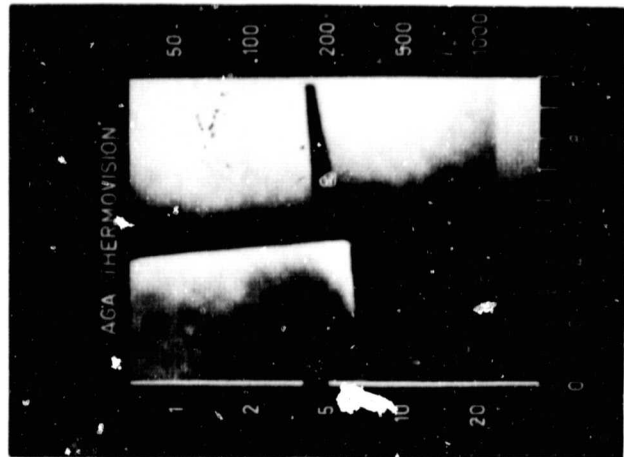
Plate IV- Plate IV contains test results of specimen IV. Pictures 4b, 4c, and 4d, taken in the evening, show area C as the coolest with a section of A cooler than B and D. Very little differentiation exists between B and D. Various RTL's and DL's were used to examine the specimen. Pictures 4e and 4f, taken in the morning, again show area C as the coolest. Photo 4f has poor resolution due to sunrays scattering off the surface. Equal RTL's and DL's were used.

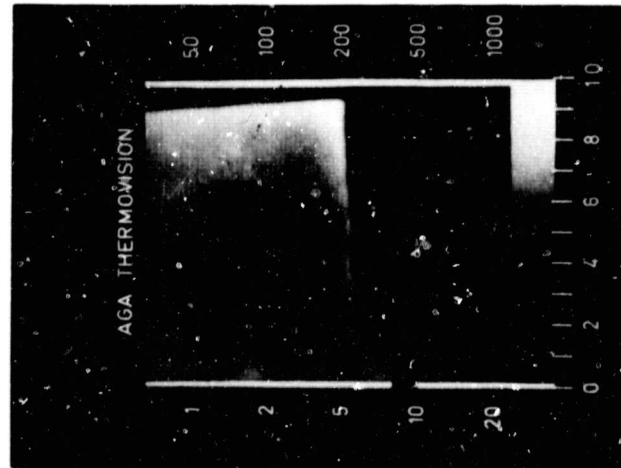
4d
AC

9:40 p.m.
can't tell any difference
between B & D now

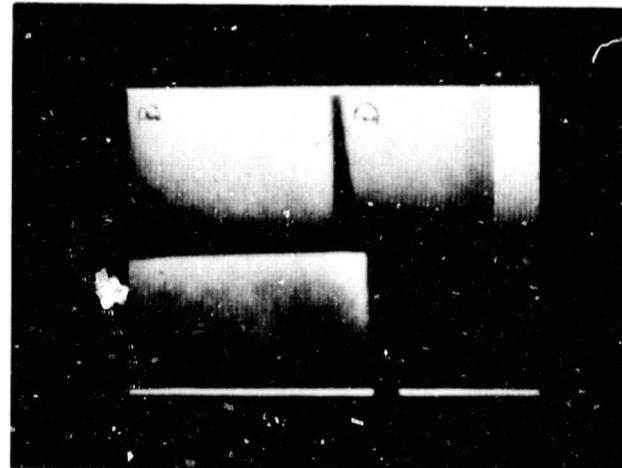
7:00 a.m.
Shaded

7:43 p.m.
In Sun

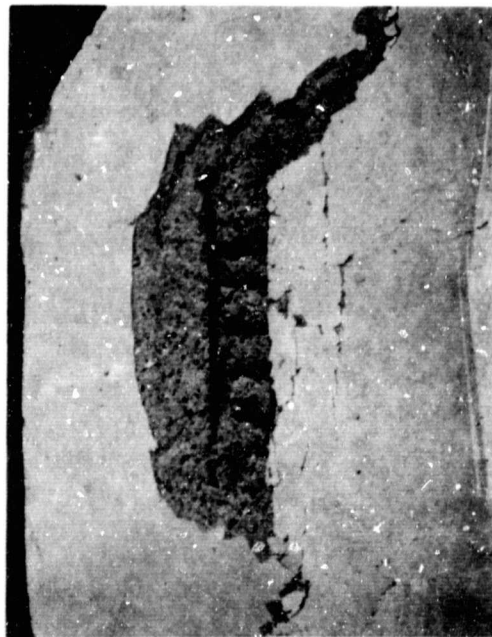
SPECIMEN V - 5a

Specimen V (Fig. 5a), is another section of the octagonal slab. It contains several exposed reinforcing bars due to concrete separation and removal. The dark area in the center of the photo shows exposed aggregate and slopes from the surface to the bars; this exemplifies spalling. The surface area surrounding the niche (spalled area) contains solid and subsurface delaminated portions.

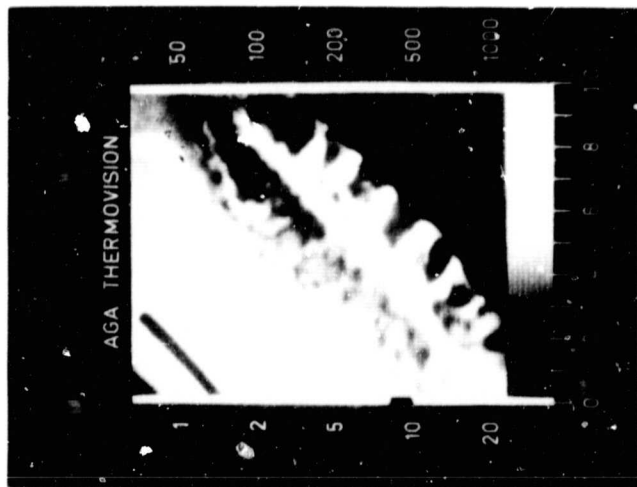
5b 6-5-69 8:40 p.m.
Isotherm

Plate V - Plate V contains test results of specimen V. Picture 5b, evening shot, shows the solid concrete (upper-left) as warmer. A metal rod is in the solid section. The support rods are very warm while the delaminated concrete (lower-right) is coolest. The exposed aggregate is slightly cooler than the solid portion, Figures 5c, 5d, 5e, and 5f are a morning sequence. These show the same delineation as in 5b with resolution becoming worse as the sun's rays scatter more from the surface.

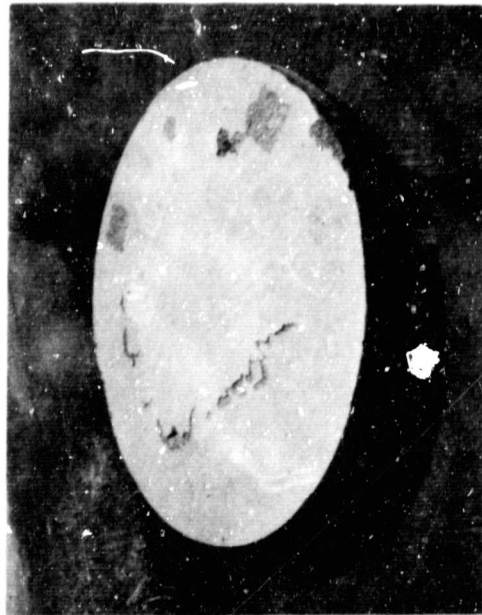
SPECIMEN VI - 6a

Specimen VI, (Fig. 6a), is a round lightweight slab of the same type as the octagonal slab. It contains areas of sound and delaminated concrete and is used only as an additional specimen for support data.

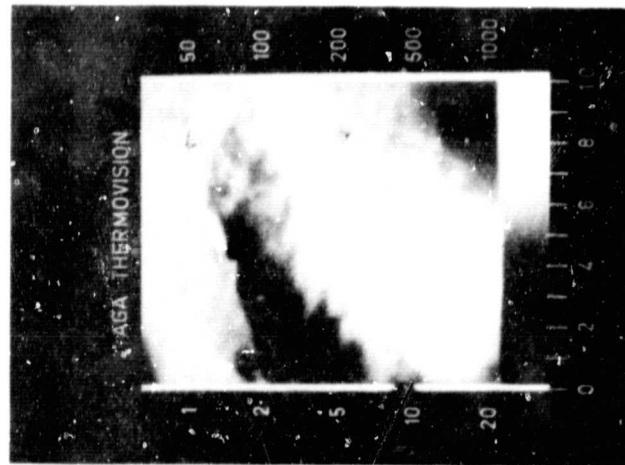
6b 6-6-69 8:25 p.m.
Dry

Plate VI - Plate VI contains test results of specimens VI and VII. Figure 6b shows delaminated areas at the cracks as cooler than the center or outlying portions of the slab. Figure 6c shows the same area two minutes after water was doused on the specimen. A crack now appears at the center surface. With both pictures at equal RTL's and DL's, the doused slab is seen to be the cooler.

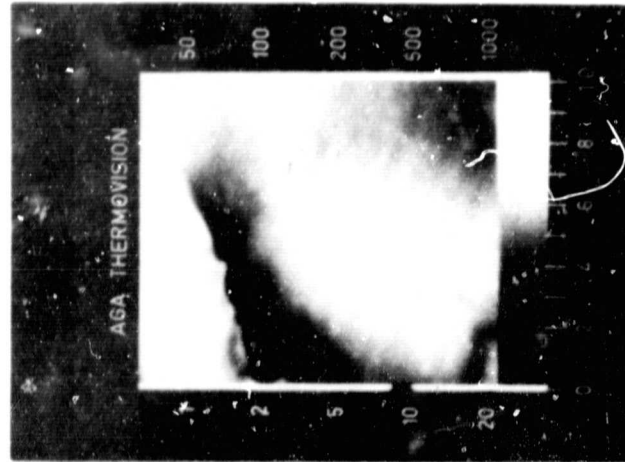
6c 6-6-69 8:30 p.m.
After flushing with water

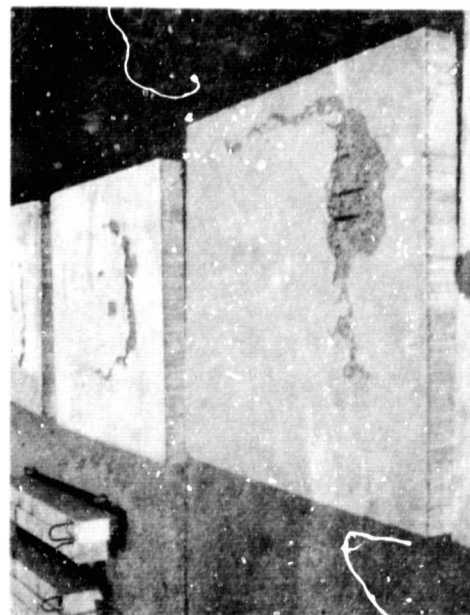
SPECIMEN VII - 7a

Specimen VII, (Fig. 7a), is a square, lightweight slab of the same type as the octagonal slab. The center is delaminated and the edges are solid. The exposed aggregate is sound. The ends of four vertical bars at the center of the slab appear as a square array of dots, figure 7b. This specimen is used for additional support data.

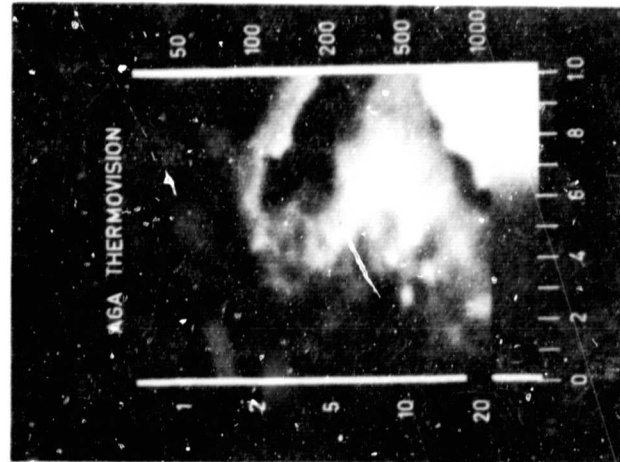
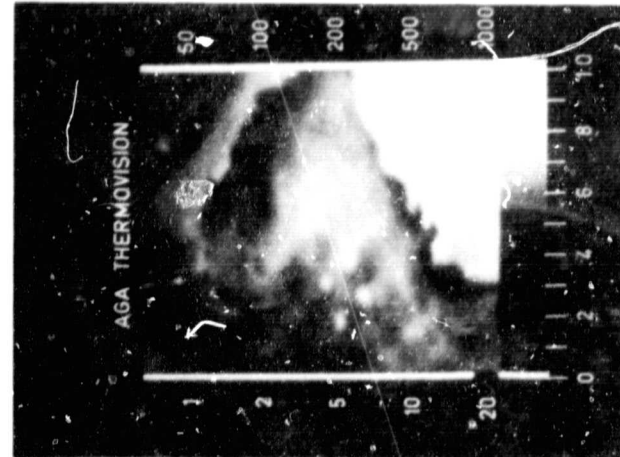
Figure 7b and 7c show a nighttime view (10:00 p.m.) of specimen VII. The delaminated inner portions appear cool, while the solid outer portions of the slab is warm. The four iron bars arranged in a square fashion at the center with their ends at the surface appear to be warmer than the surrounding delaminated concrete. The exposed, solid aggregate in the lower right hand portion of the pictures appears to be the warmest area.

7b 6-6-69 9:55 p.m.
Dark areas delaminated, light areas solid

7c 6-6-69 10:00 p.m.
Dark areas delaminated, light areas solid
